# PHASE I INSPECTION REPORT

## NATIONAL DAM SAFETY PROGRAM

Clifton Forge Dam (Inventory Number  
VA 00503). James River Basin.

Alleghany County, Virginia.  
Phase I Inspection Report.

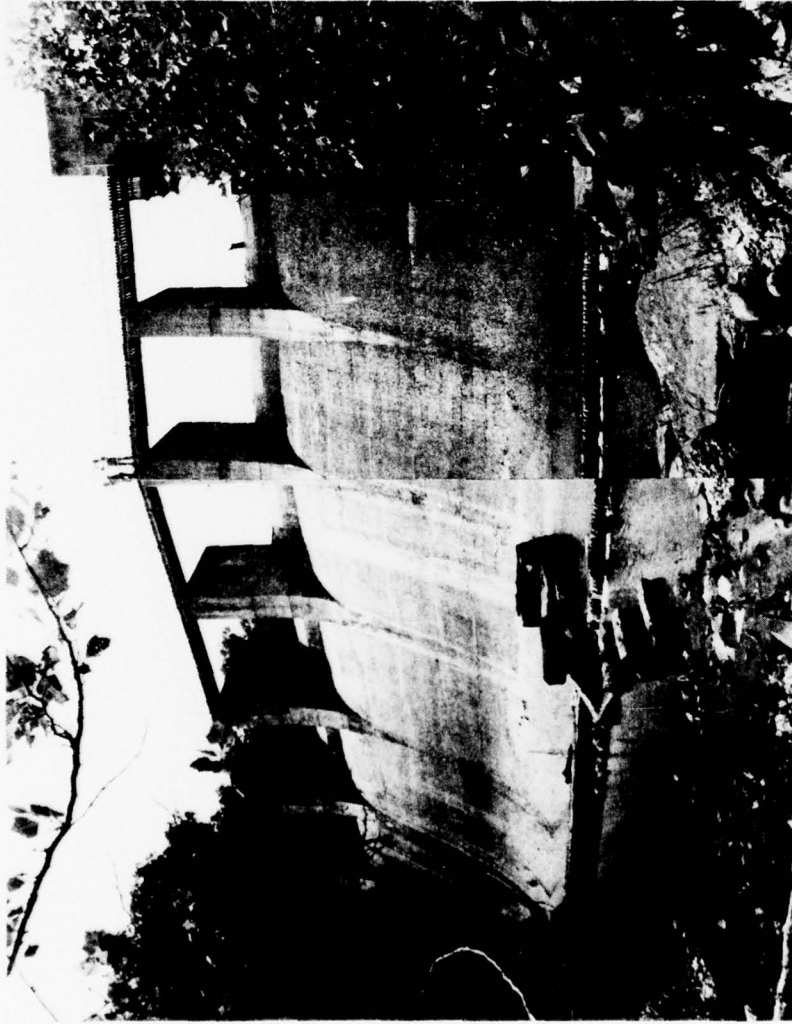
OVERVIEW - CLIFTON FORGE DAM

Based on the visual inspection, the dam did not appear to be in an imminently dangerous condition; however, there are seepage conditions which could become hazardous. Calculations indicate that the dam has inadequate factors of safety with respect to structural stability. A seepage condition at the left abutment requires monitoring to detect increases in flow rate. The spillway can only pass up to 50 percent of the probable maximum flood (PMF) before overtopping occurs. (See Appendix VII, Conditions.)

The recommendations provided in this Report pertain to the structural stability and also to the general management of the dam. Except for the additional stability studies and the establishment of a warning system, they are not of an urgent nature. Briefly, the recommendations call for additional stability studies, the establishment of a warning system, a semiannual inspection program, and the maintenance of a file of all design documents and related materials. Minor maintenance, such as removing the

concrete debris from the old 12-inch downstream pipeline and repair of the scaling concrete, should be done. It is also suggested that future consideration be given to increasing the spillway capacity.

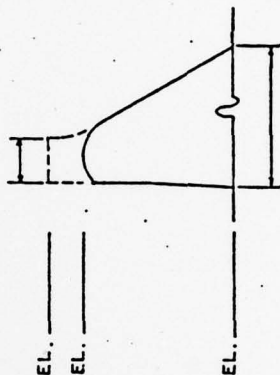
ANALYSIS DONE ON X FULL SECTION PARTIAL SECTION  
LOCATION OF SECTION CLIFTON FORGE SPILLWAY  
ANALYSIS PREPARED BY D.C. RECHWARD

LOADING CASE	ELEV. HEAD WATER	ELEV. TAIL WATER	$\Sigma V$	$\Sigma H$	$\frac{\Sigma H}{\Sigma V}$	LOCATION RESULTANT FROM TOE	% BASE COMPRESSION IN	FACTOR SAFETY SLIDING	FOUNDATION PRESSURE	
									TOE	HEEL
PMF	1412.8		68.9 K/FT	99.1 K/FT	1.44	3.53 FT	26%	1.71	13.01 KSF	0. KSF
$\frac{1}{2}$ PMF	1408.0		76.5	86.5	1.13	9.01	68%	2.02	5.66	0.
NORMAL WATER LEVEL + ICE	1396.0		95.1	60.0	0.63	16.73	100%	3.16	3.54	1.21

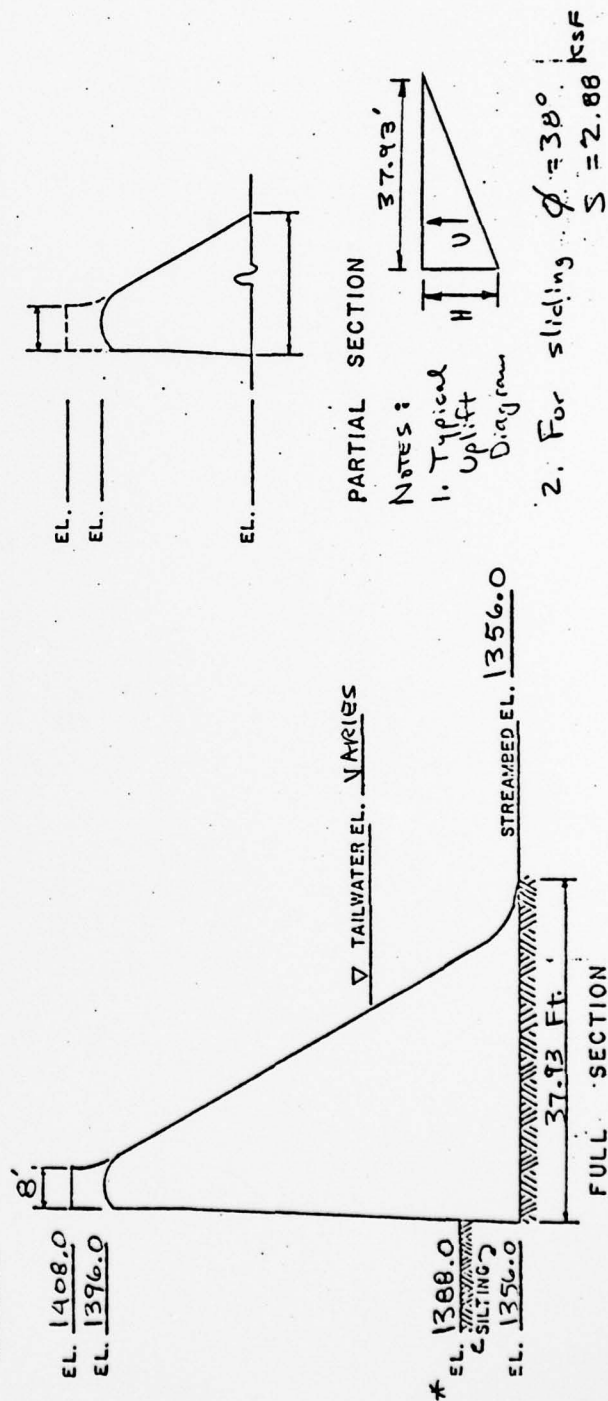
ANALYSIS DONE ON  $\checkmark$  FULL SECTION — PARTIAL SECTION  
 LOCATION OF SECTION CLIFF TOP FORCE BULKHEAD  
 ANALYSIS PREPARED BY T. SCHKEFFEL

LOADING CASE	ELEV. (FT)		$\Sigma V$ (K/FT.)	$\Sigma H$ (K/FT.)	$\Sigma H$ EV	LOCATION RESULTANT FROM TOE (FT.)	% BASE COMPRESSION IN	FACTOR SAFETY SLIDING	FOUNDATION PRESSURE	
	HEAD WATER	TAIL WATER							TOE (KSF)	HEEL (KSF)
PM F	1412.8	1368.0	84.3	117.3	1.39	2.99	24%	1.49	18.8	0
1/2 PM F	1408.0	0	104.2	101.0	.97	9.78	77%	1.89	7.10	0
Normal Water Level + ICE	1396.0	0	118.3	71.64	.61	16.69	100%	2.82	4.24	2.00
